CARR-1308

Lewis Snyder Farm
5246 Carroll Warehime Road
Lineboro (Vicinity)

Maryland Historical Trust State Historic Sites Inventory Form

Lewis Snyder Farm-House
5246 Carroll Warehime Road

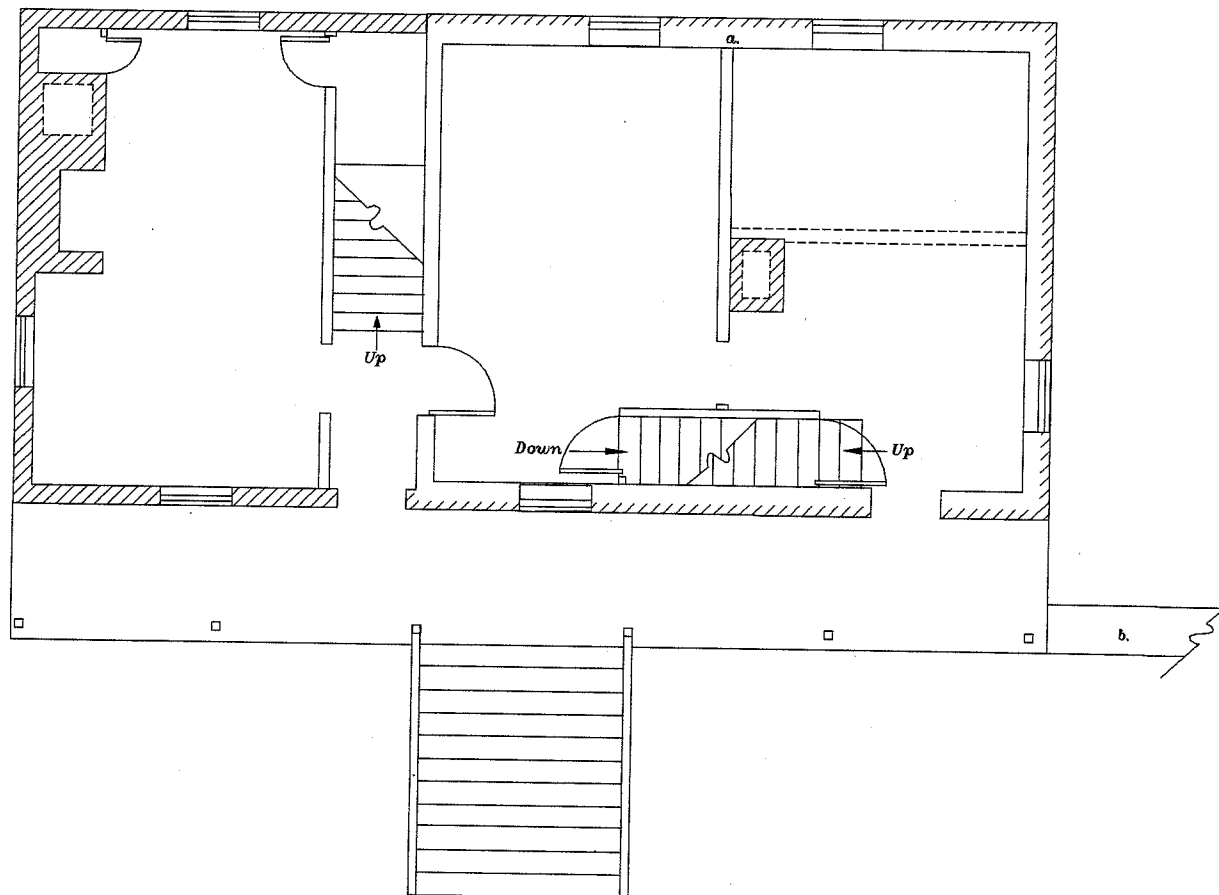
First Floor
Plan

a. Log
b. Stone

The interior has had slight modifications. The interior layout is a three-cell plan with modified central passage between the new and old buildings. The log section is

divided laterally by a northeast to southwest wall. The northwest cell which has the exterior door, was originally divided into two unequal rooms by a wall that ran northwest to southeast.

The back room was narrow. The front room has a brick chimney, but no fireplace. There is a kitchen fireplace in the basement, under the central cell, that probably used this flue. The stairs are enclosed and are placed against the northeast wall, spanning both the central and northwest cells. The entrance up to the second story is from the northwest cell, and to the basement is from the center cell.

The brick addition has a central enclosed stair in the modified passage that separates it from the center cell. This narrow passage has an external door to the front and interior doors to the central and southeast cells, but since the stairs are enclosed, there is no passage along side them to the rear of the building. The southeast cell contains a fireplace and flue for a kitchen fireplace that was originally in the basement. There is a built-in closet in the south corner of the room. The flat window frames in this section have a beaded interior edge.

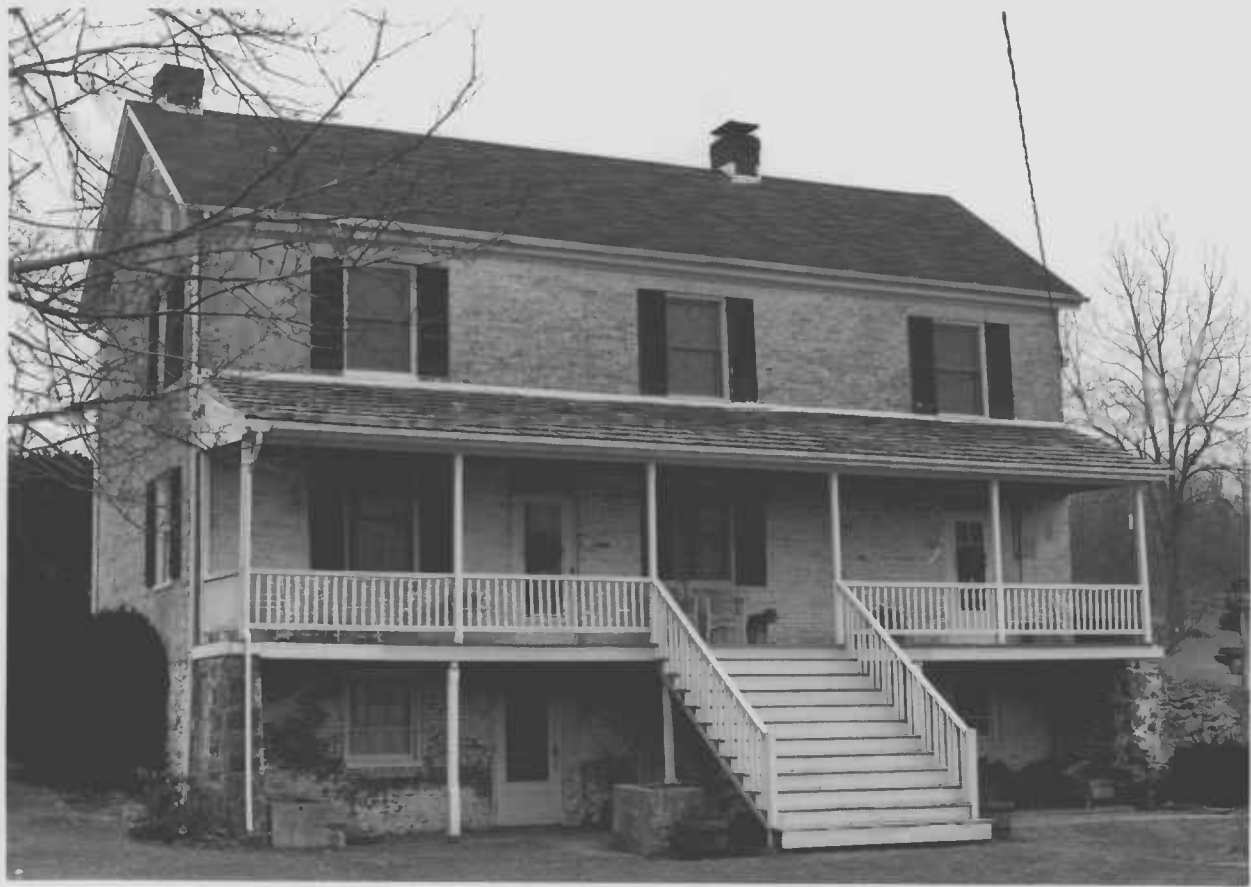
1/6

House - NE elev.

The house at 5246 Carroll Warehime Road is a two-story all stretcher common bond brick building banked into a hill on the southeast side, with a porch across the first-story front and exposed basement on the northeast facade. The building represents at least two distinct construction phases. The northwestern half was constructed first as a two-story log house on a stone foundation. The southwestern half is a two-story brick addition, also on a stone foundation. When it was constructed, the original log house was encased in brick, making the structure read as one. This history helps explain its unique pattern of window and door placement. The exposed basement wall is five bays long and of brick, with projecting stone end walls that support the ends of the porch above, and a stone pier between the doors in the second and third bays. These doors are both of vertical tongue and grooved boards with a fixed 6 light sash in the top of each. The other bays contain 6 over 3 wood double-hung sash with wood sills. There are also three wood posts which support the porch above. The porch has a shed roof with wood shakes, six squared posts with chamfers and stops above the railings, and vertical square balusters. The porch has a wide central stairway of wood and new concrete and brick stairs behind a stone wall on the northwest end. All of the windows in the first and second stories have been replaced with recent 6-over-6 or 1-over-1 sash. The first story front has windows in the first and third bays, and doors in the second and fifth bays. On the second story there are windows in the first, third and fifth bays. The house has a gable roof of asphalt shingles, a flush brick chimney centered on the southeast wall, and a chimney over the fourth bay. There are exterior panelled shutters on the first story and louvered blinds on the second.

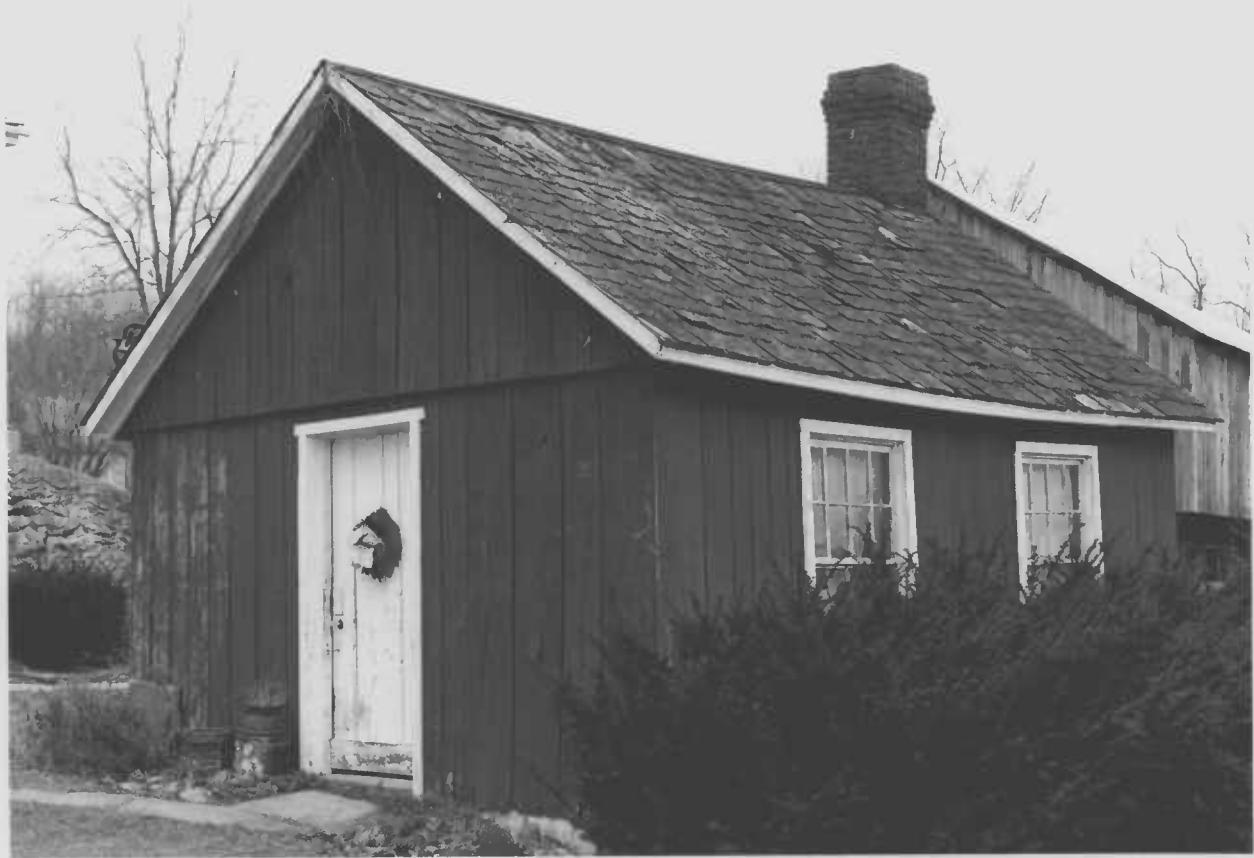
Neg. Loc. Maryland Historical Trust
Summer Kitchen - SE & NE elev
3/6

Northeast of the house is a one-story summer kitchen with sawn and nailed wood frame on a stone foundation and vertical board wood siding. It has a gable roof with wood shingles 6"x24" with 9" weather. The building is one bay by two bays, with a vertical board wood door on the southeast gable end and an interior brick fireplace with iron kettle rollers on the opposite northwest end. Both sides have two 8-over-8 double hung wood sash.

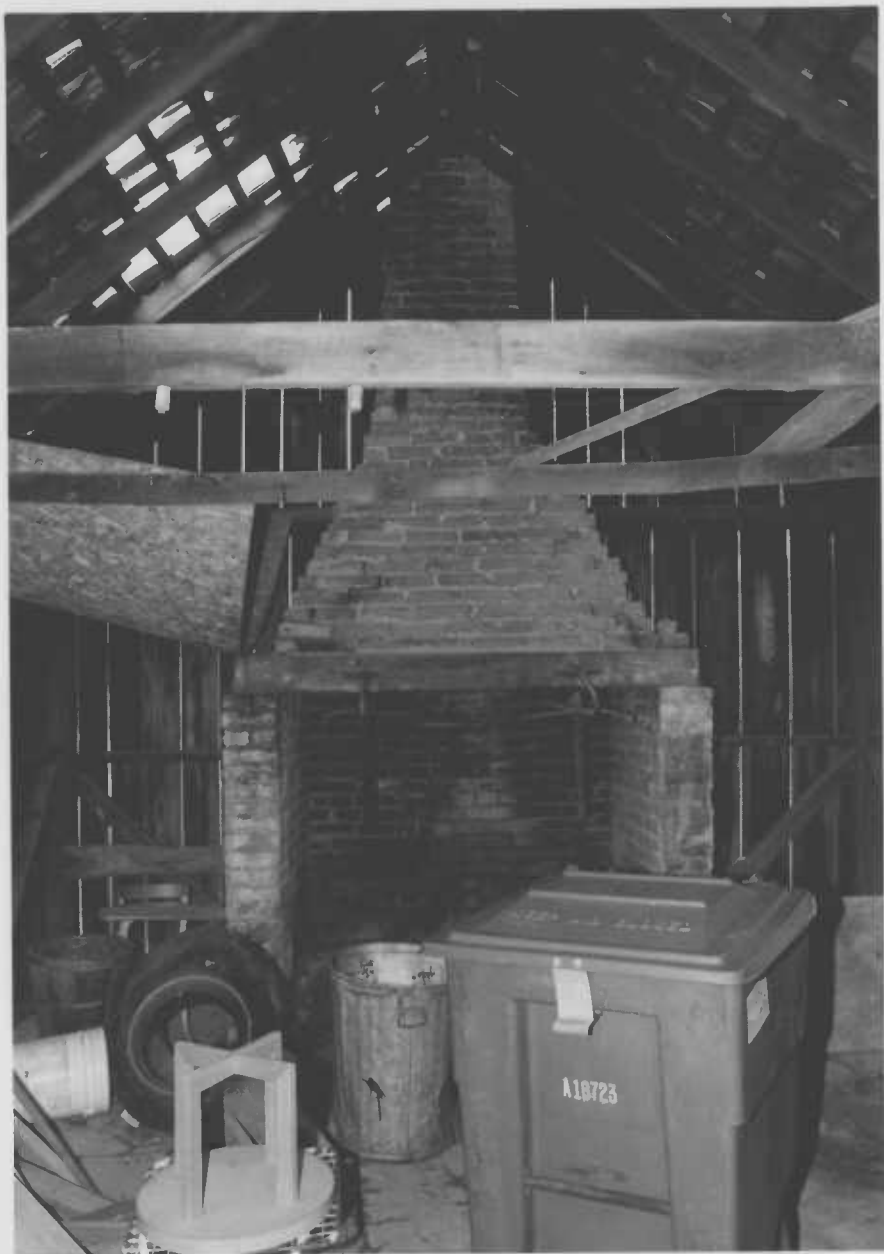
7/6

Summer Kitchen - interior SW - NW

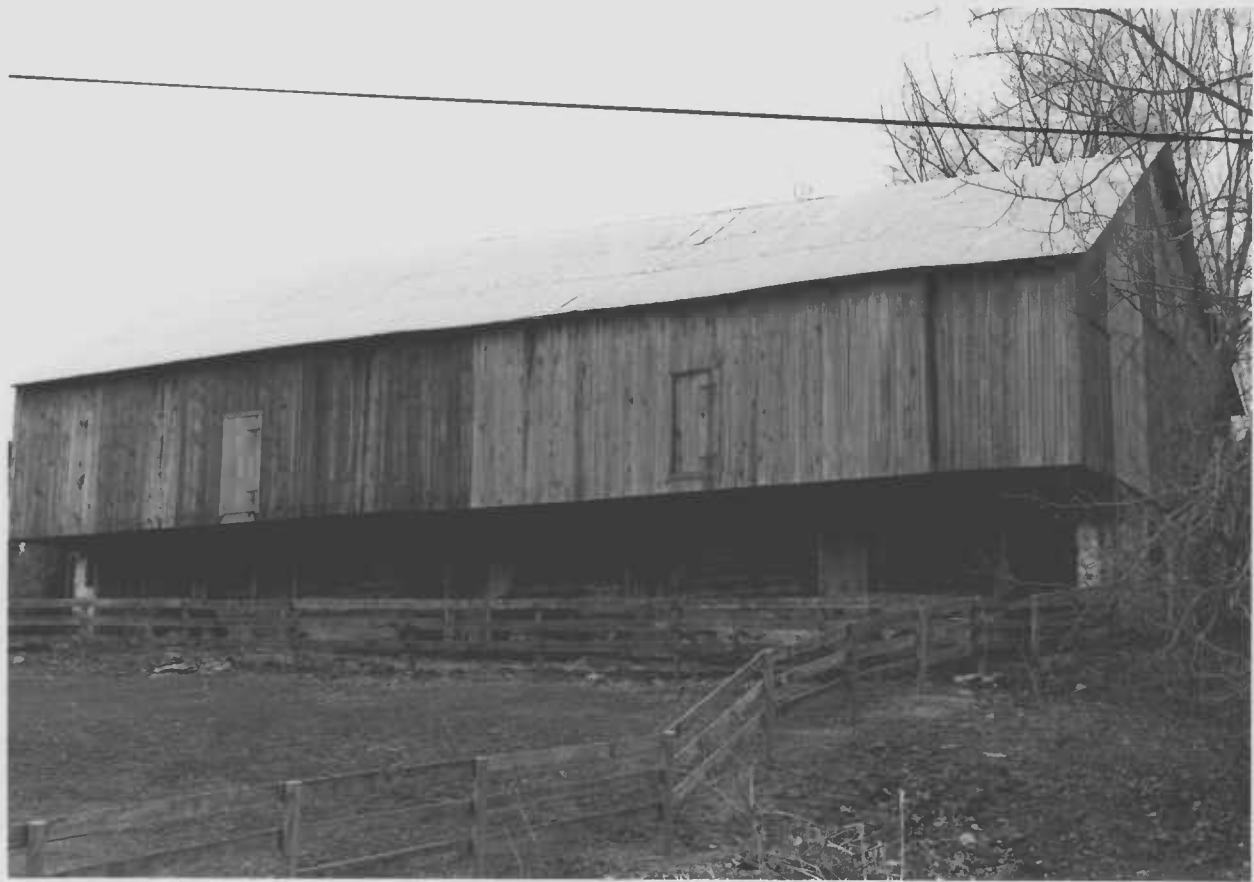
5/6

Barn - NE elev.

Northwest of the house and in line with it is a banked barn with a ramp on the southwest side and forebay on the northeast. It has a rubble stone foundation with a horizontal board wall under the forebay. This wall has seven doors, which were originally vertical board dutch doors on strap hinges, several of which have been replaced recently. Between the doors are five wood louvered vents placed high up on the wall. The third and fourth doors are set close together, without sufficient space for a vent.

missing and the other is rebuilt and has strap hinges. The barn has a gable roof with corrugated metal roofing. There are several 6 light sash, probably reused from the house, that were placed in the barn when it was re-sided. The northeast elevation has two pairs of double doors at the ends of the two threshing floors, placed opposite the large wagon doors on the southwest elevation. Inside the barn on a threshing floor wall are carved the initials "R.L.H.," "C.E.H.," and "W.L.L.?".

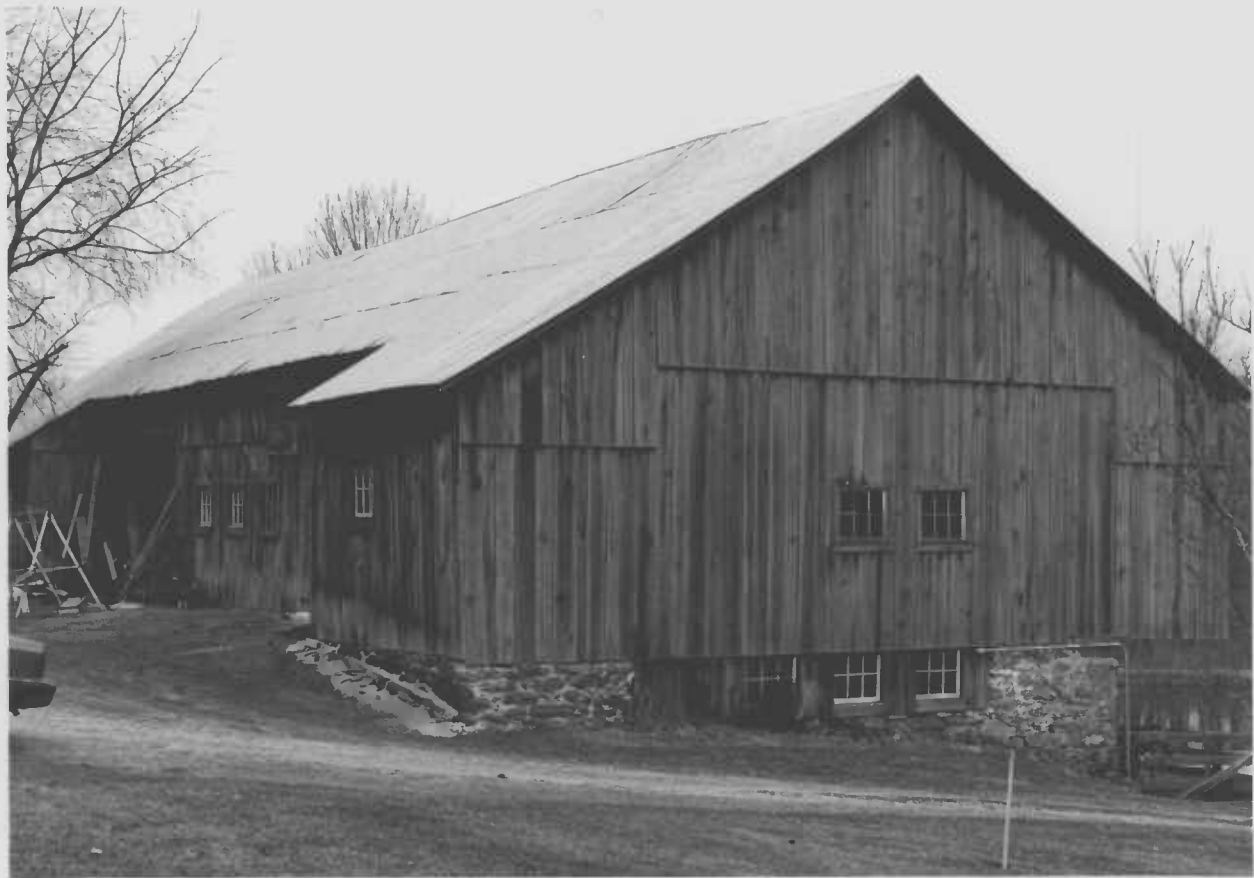
6/6

Burn - SW & SE elevs.

The plan of the first story has a hay mow on each end and one in the center, with two threshing floors. The first story of the barn has vertical wood siding, much of it new. The southwest elevation has projecting end sheds, the left one containing the remains of a granary. There are two sets of double doors, the left pair has one door
